DEPARTMENT OF TRANSPORTATION

Contract #: 04-0120F4Cty: SF/ALA Rte: 80 PM: 13.2/13.9File #: 69.28**WELDING INSPECTION REPORT****Resident Engineer:**Siegenthaler, Peter**Address:** 333 Burma Road**City:** Oakland, CA 94607**Report No:** WIR-017400**Date Inspected:** 07-Oct-2010**Project Name:** SAS Superstructure**OSM Arrival Time:** 700**Prime Contractor:** American Bridge/Fluor Enterprises, a JV**OSM Departure Time:** 1900**Contractor:** Zhenhua Port Machinery Company, Ltd (ZPMC), Changxing Island **Location:** Shanghai,China**CWI Name:** Mr.Xu Tao/Li Yan Hua**CWI Present:** Yes No**Inspected CWI report:** Yes No N/A**Rod Oven in Use:** Yes No N/A**Electrode to specification:** Yes No N/A**Weld Procedures Followed:** Yes No N/A**Qualified Welders:** Yes No N/A**Verified Joint Fit-up:** Yes No N/A**Approved Drawings:** Yes No N/A**Approved WPS:** Yes No N/A**Delayed / Cancelled:** Yes No N/A**Bridge No:** 34-0006**Component:** OBG**Summary of Items Observed:**

WELDING INSPECTION REPORT

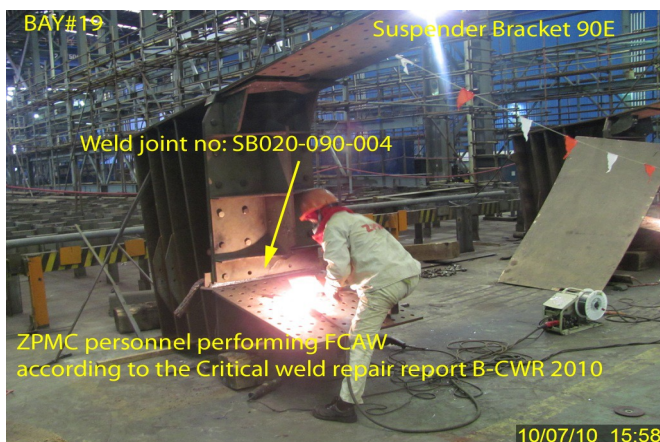
FCAW welding of weld joint no: SB020-090-004 located on OBG Suspender Bracket SB 090E. Welder is identified as #062749. ABF QA is identified as Mr. Peng Wei Jun. Welding was performed according to the Critical weld repair report B-CWR 2010 and MT report number: B787-MT-30232.The welding variables recorded by QC appeared to comply with the WPS-345-FCAW-2G(2F)-Repair. Please see the attached picture.

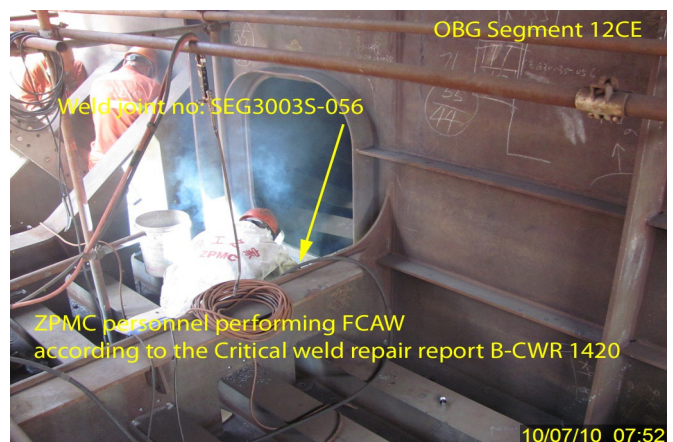
FCAW welding of weld joint no: SEG3003S-056 located on OBG Segment 12CE Longitudinal Diaphragm. Welder is identified as #068501. ZPMC CWI is identified as Mr. Li Yan Hua. Welding was performed according to the Critical weld repair report B-CWR 1420 and MT report number: B787-UT-12371R1. The welding variables recorded by QC appeared to comply with the WPS-345-FCAW-2G(2F)-Repair. Please see the attached picture.
